DEPARTMENT OF TRANSPORTATION

Quality Assurance and Source Inspection

Contract #: 04-0120F4Cty: SF/ALA Rte: 80 PM: 13.2/13.9File #: 1.28**WELDING INSPECTION REPORT****Resident Engineer:**Siegenthaler, Peter**Address:** 333 Burma Road**City:** Oakland, CA 94607**Report No:** WIR-025378**Date Inspected:** 29-Jul-2011**Project Name:** SAS Superstructure**OSM Arrival Time:** 700**Prime Contractor:** American Bridge/Fluor Enterprises, a JV**OSM Departure Time:** 1530**Contractor:** American Bridge/Fluor Enterprises, a JV**Location:** Job Site**CWI Name:** Steve Mc Connell**CWI Present:** Yes No**Inspected CWI report:** Yes No N/A**Rod Oven in Use:** Yes No N/A**Electrode to specification:** Yes No N/A**Weld Procedures Followed:** Yes No N/A**Qualified Welders:** Yes No N/A**Verified Joint Fit-up:** Yes No N/A**Approved Drawings:** Yes No N/A**Approved WPS:** Yes No N/A**Delayed / Cancelled:** Yes No N/A**Bridge No:** 34-0006**Component:** SAS Tower**Summary of Items Observed:**

At Tower Base Elevation 13Meters Shear Plate Electro Slag Welding (ESW);

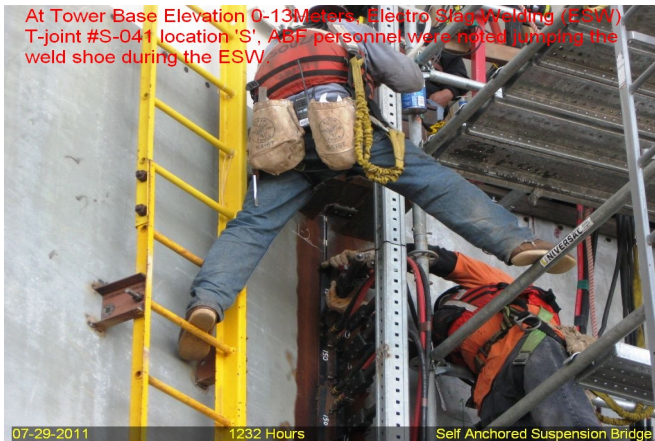
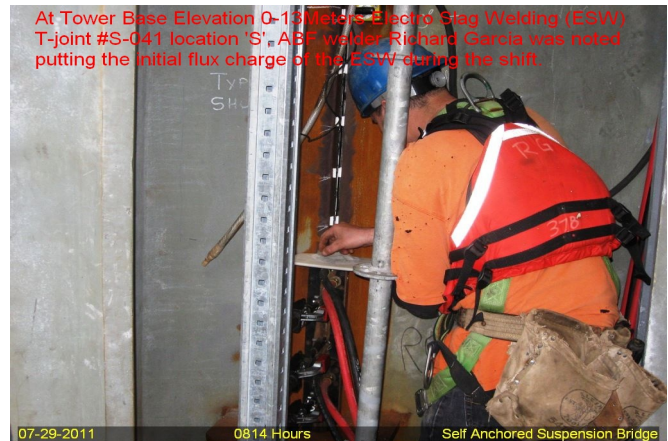
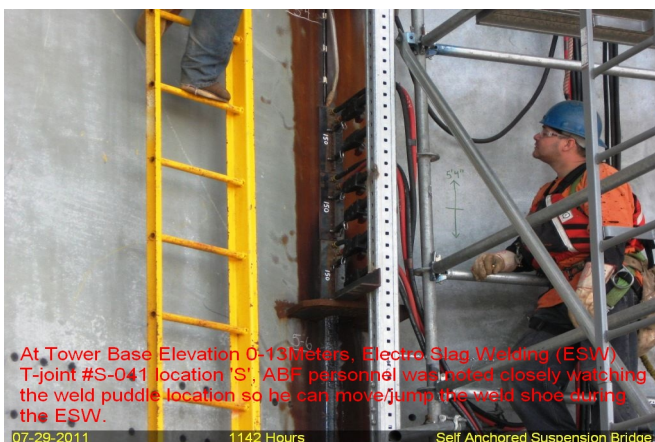
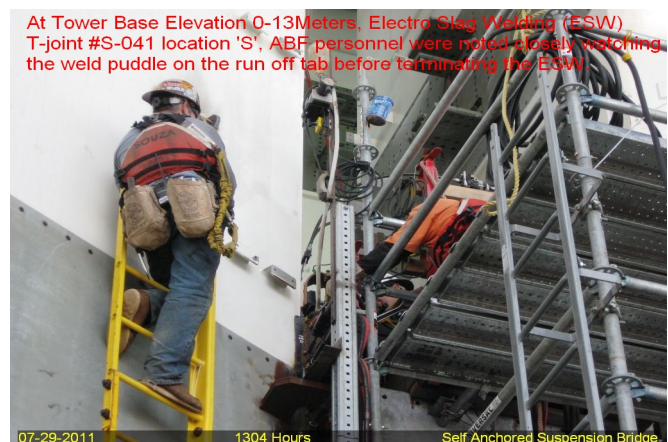
After the placement of the flux initial charge at around 0815 hours, firing of the ESW has started at 0833 hours and it was successful and that the welding parameters have stabilized and continued without a hitch until the completion at 1306 hours for a total ESW welding time of four (4) hours and thirty three (33) minutes. The surface profile of the completed ESW weld joint also appears satisfactory and deemed in compliance to the contract requirements.
